Full Report

Inspection Details

Home Inspection Report

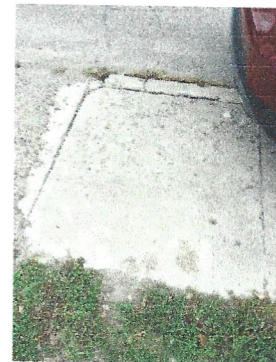
Concrete pitted and chipped

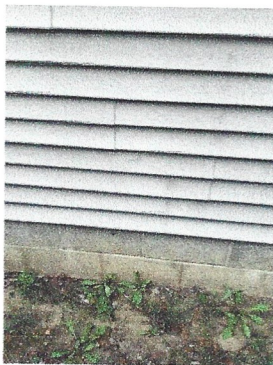
Crack

small cracks in siding right side of house near back corner

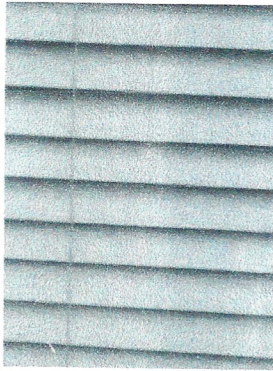
Screens torn/damaged

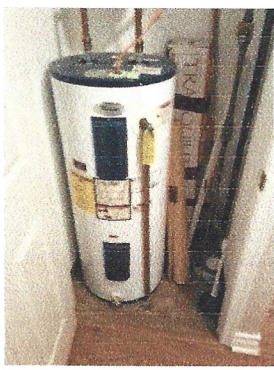
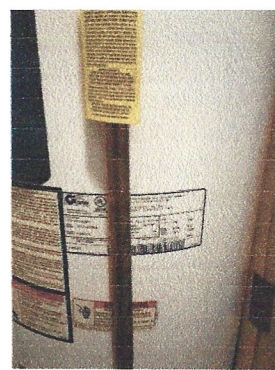
looks like hot water tank was manufactured in 2010

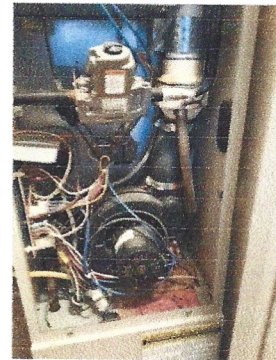
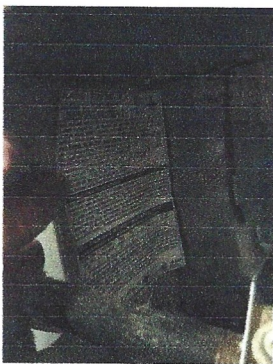
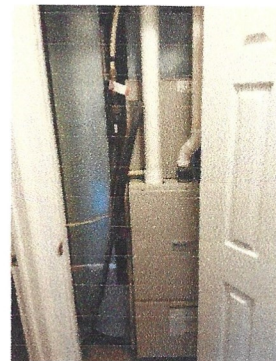
Furnace nearing the end of its design life Furnance was manufactured the 4th month of 2002

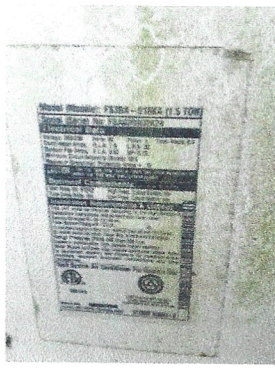
Unable to test due to season/exterior temperature

Unit is nearing the end of its design life. unit was manufactured 09 of 03

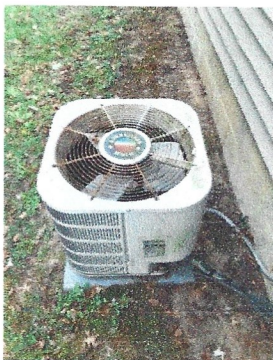
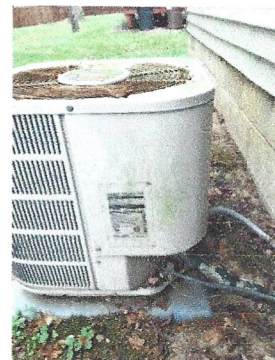
Excessive rust

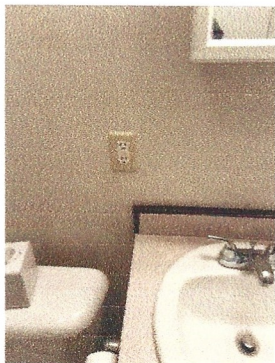
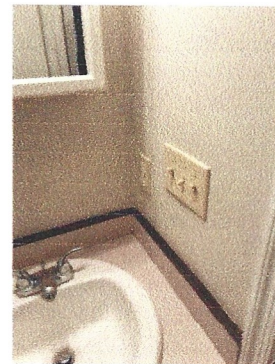
Non-GFCI circuit

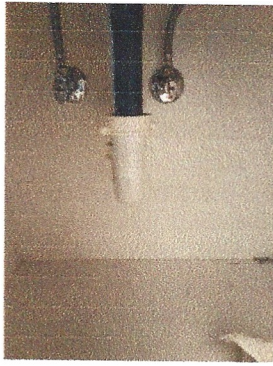
Leaking faucet

Leaking trap

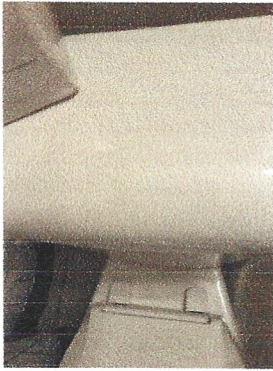
Lid

lid is cracked in front

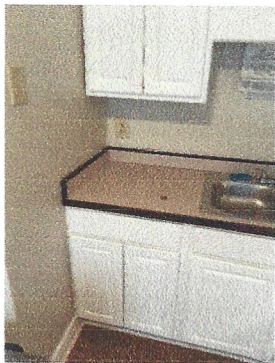
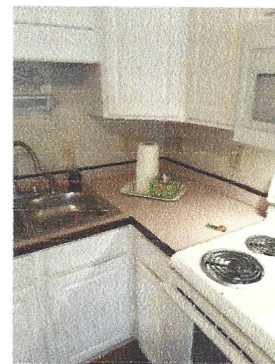
Non-GFCI circuit around kitchen sink

Requires Attention
