Full Report

Inspection Details

Home Inspection Report

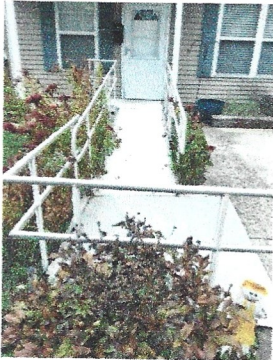
1.2 WALKS

Concrete pitted and chipped

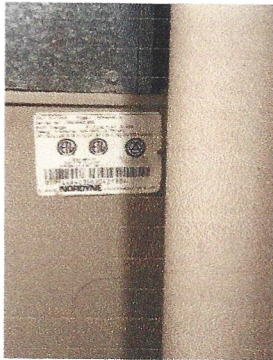
8.2 HEATING SYSTEM

Furnace nearing the end of its design life Furnance was manufactured the 4th month of 2002

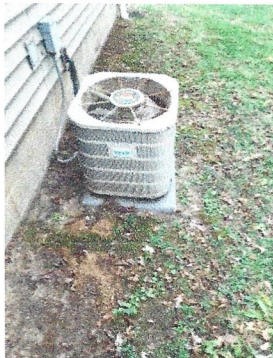
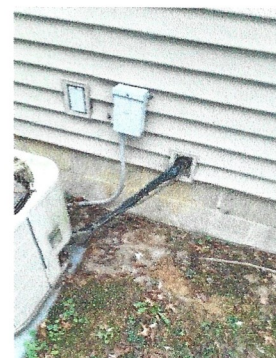
8.5 COOLING SYSTEM

Unable to test due to season/exterior temperature

Unit is nearing the end of its design life. unit was manufactured 09 of 03

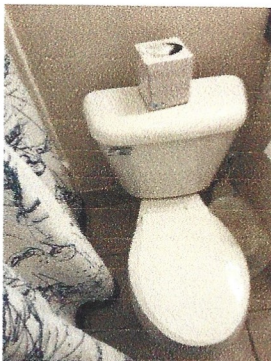
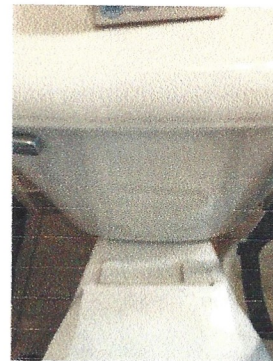
9.5 TOILETS

Lid

lid is cracked in front
